# Manhole Inspection Summary

Manhole # S37G\_\_045MH

Insp Date: 1/14/09 9:23 AM

**Location** Address: **44 south st**

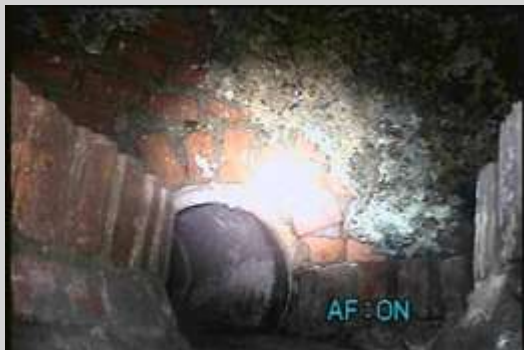
12 O'Clock Outflow

15 in. Circular Gravity Sewer  
Pipe Out @ 12 OClock

best shot  
camera cant reach

Pipe Material: Clay ☐ Pipe Lined

Invert Depth: 15.70 (ft.) Flow Characteristics: Slow

Infiltration: None Pipe Seal Cond: Unknown

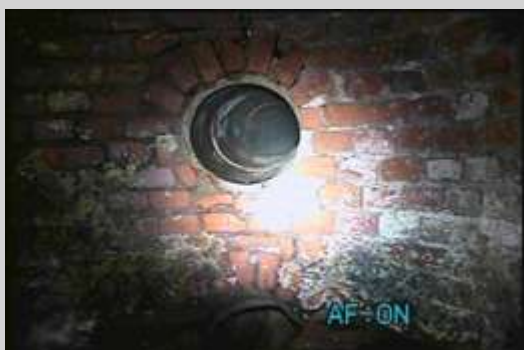
3 O'Clock Inflow

10 in. Circular Gravity Sewer  
Pipe In @ 3 OClock

Drop In @ 3 OClock

best shot

Pipe Material: Clay ☐ Pipe Lined

Invert Depth: 13.83 (ft.) Flow Characteristics: Slow

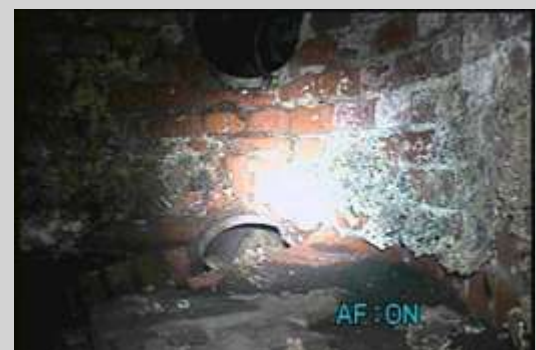
best shot

Drop: Outside Direct

Inv Depth: 15.66 (ft.)

Drop Condition: Open

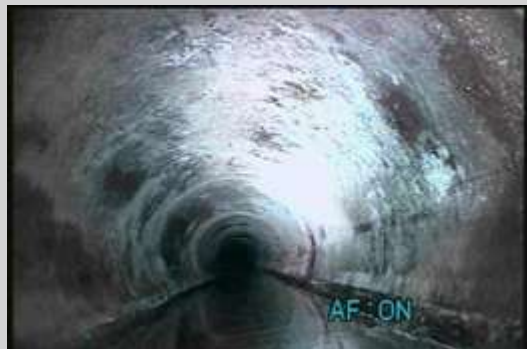
6 O'Clock Inflow

12 in. Circular Gravity Sewer  
Pipe In @ 6 O'Clock

Pipe Material: **Clay** ☐ Pipe Lined

Infiltration: **None** Pipe Seal Cond: **Unknown**
